Tech Bulletin #9
August 10, 2012

Death Wobble on 2006 Sterlings

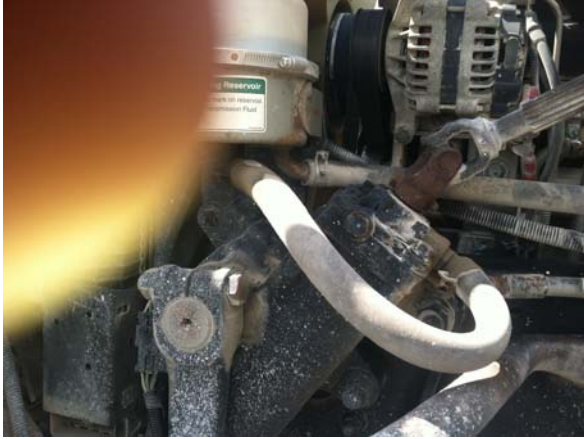
What I think is happening: I believe the wobble is a product of the front tires steering left to right and back. The lack of control is due to air in the steering gear box. Since air can compress, any contamination of the hydraulic fluid with air can result in a rebound oscillation in the steering wheel. Where is the air coming from and why does it trap in the gear box? The fluid reservoir on this model truck is a short, fat container. I believe that the draw on the system can lower the fluid level enough to cause air to be sucked into the lines. The gear box is set at an angle with the top of the box tilted to the rear of the truck and both supply and exhaust lines are on the back and top sides of the box. (see pic) In this configuration, any air in the system can trap in the box and will not self bleed because all the exits are below the top of the box. It should be noted that previous models of this truck did not place both supply and exhaust lines on the bottom side of the gear box.

Both hoses on one side (Back/Bottom)

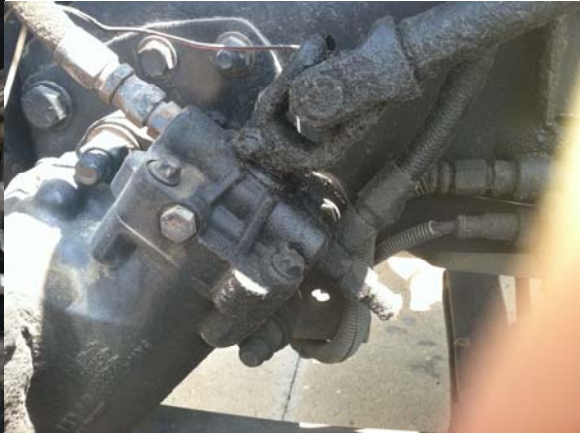
In the 80's and 90's Peterbilt had a similar setup and in order to control this issue two modifications were used. One, the fluid reservoir was taller and slimmer. This gave a greater column height which prevented the fluid draw down and protected the system from air contamination. Two, a bleed screw was placed on the top side of the gear box so that any air captured was easily vented.

One hose top one bottom

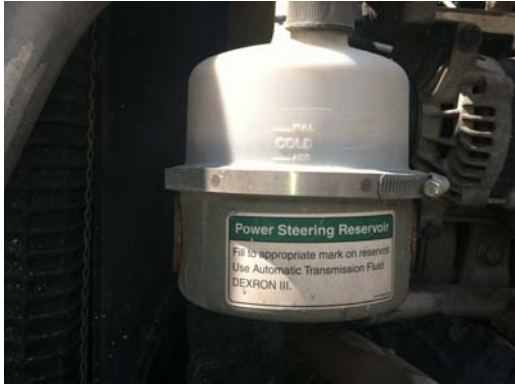
Short reservoir

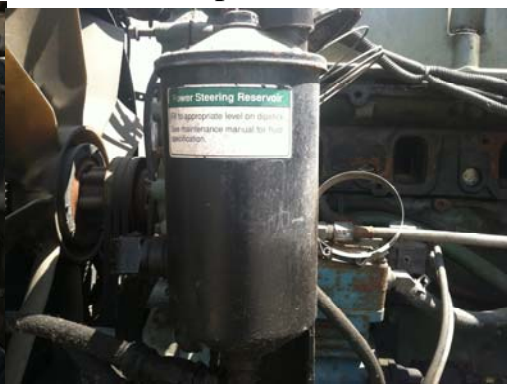
Tall Reservoir

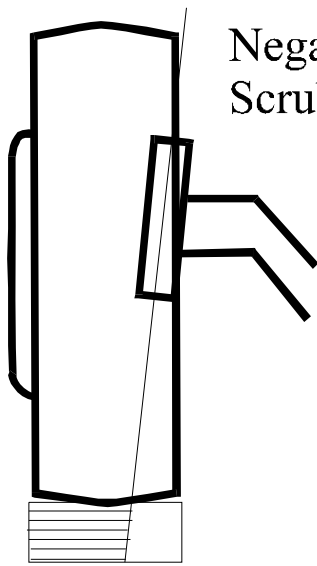
Negative Scrub Radius

drag and centrifugal force. At lower speeds, there is a built in drag in the front tires that is created by the intersection angle of the KPI on the foot print of the tire. This intersection on the inner 1/3 of the footprint causes more drag to be placed on the outer portion of the footprint which causes the tire to press toward toe out. (see illus) At about 45 MPH (70 KPH) a truck size tire spins up fast enough to create a centrifugal force capable of stabilizing the tires. Under those conditions the tire will flex toward zero toe and overcome the drag force in the foot print. This change of toe must be controlled or dampened or a wobble can manifest itself.
