Tech Bulletin #9
August 10, 2012

Death Wobble on 2006 Sterlings

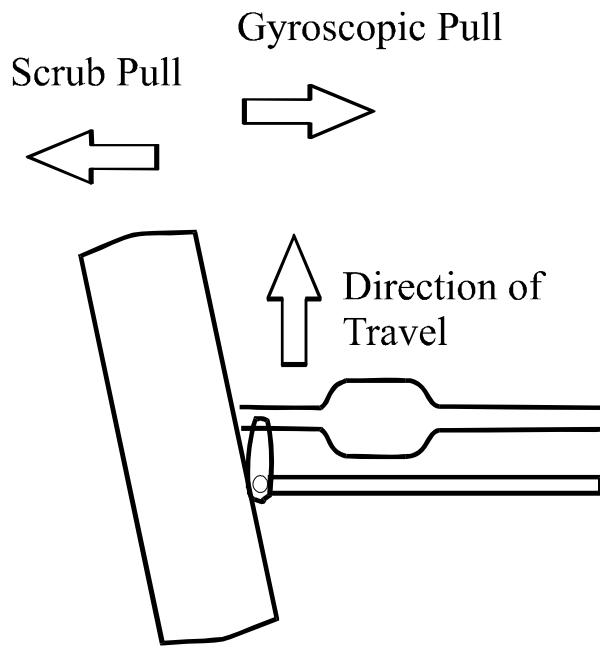
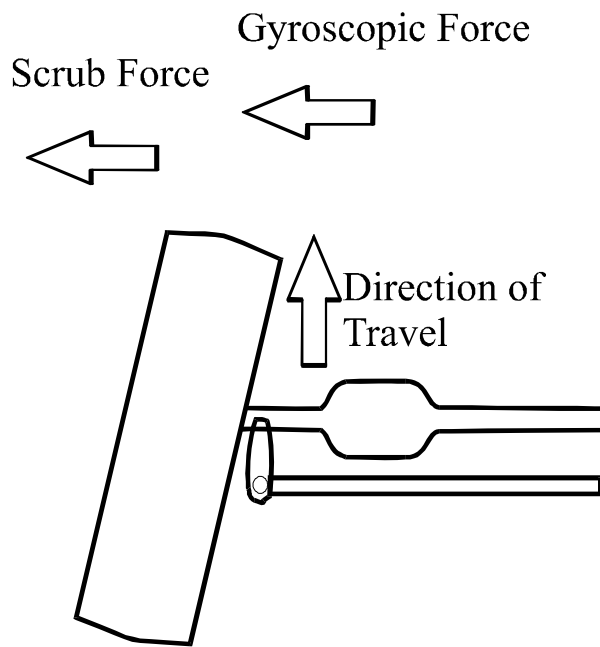
Negative Scrub Radius

drag and centrifugal force. At lower speeds, there is a built in drag in the front tires that is created by the intersection angle of the KPI on the foot print of the tire. This intersection on the inner 1/3 of the footprint causes more drag to be placed on the outer portion of the footprint which causes the tire to press toward toe out. (see illus) At about 45 MPH (70 KPH) a truck size tire spins up fast enough to create a centrifugal force capable of stabilizing the tires. Under those conditions the tire will flex toward zero toe and overcome the drag force in the foot print. This change of toe must be controlled or dampened or a wobble can manifest itself.
